CARR-1323

John Kesselring Farm
3650 Senft Road

Maryland Historical Trust State Historic Sites Inventory Form

Summary: The John Kesselring farm, located at 3650 Senft Road, about three miles northeast of Taneytown in Carroll County, Maryland, consists of a log and frame house, built in three stages, that faces east toward the road. There is also a bank barn, built in two stages. The farm also contains a shed, but other outbuildings were destroyed in a fire around 1979. The house is a two-story, four-bay by two-bay structure with a two-bay by three-bay ell on the west, and is covered in vinyl siding over the earlier German siding. The foundation is of rubble stone. It has a gable roof with standing seam metal covering, and box cornice with returns. There is a one-story wrap-around porch on the east and north elevations, with turned posts and a standing-seam metal roof. The main block of the house is divided into two rooms with an enclosed center staircase between them that runs from west up to east. The barn was built in two stages. The first stage is a forebay, banked barn, that faces east. There is an ell attached to the north half of the east elevation. The barn has a gable roo

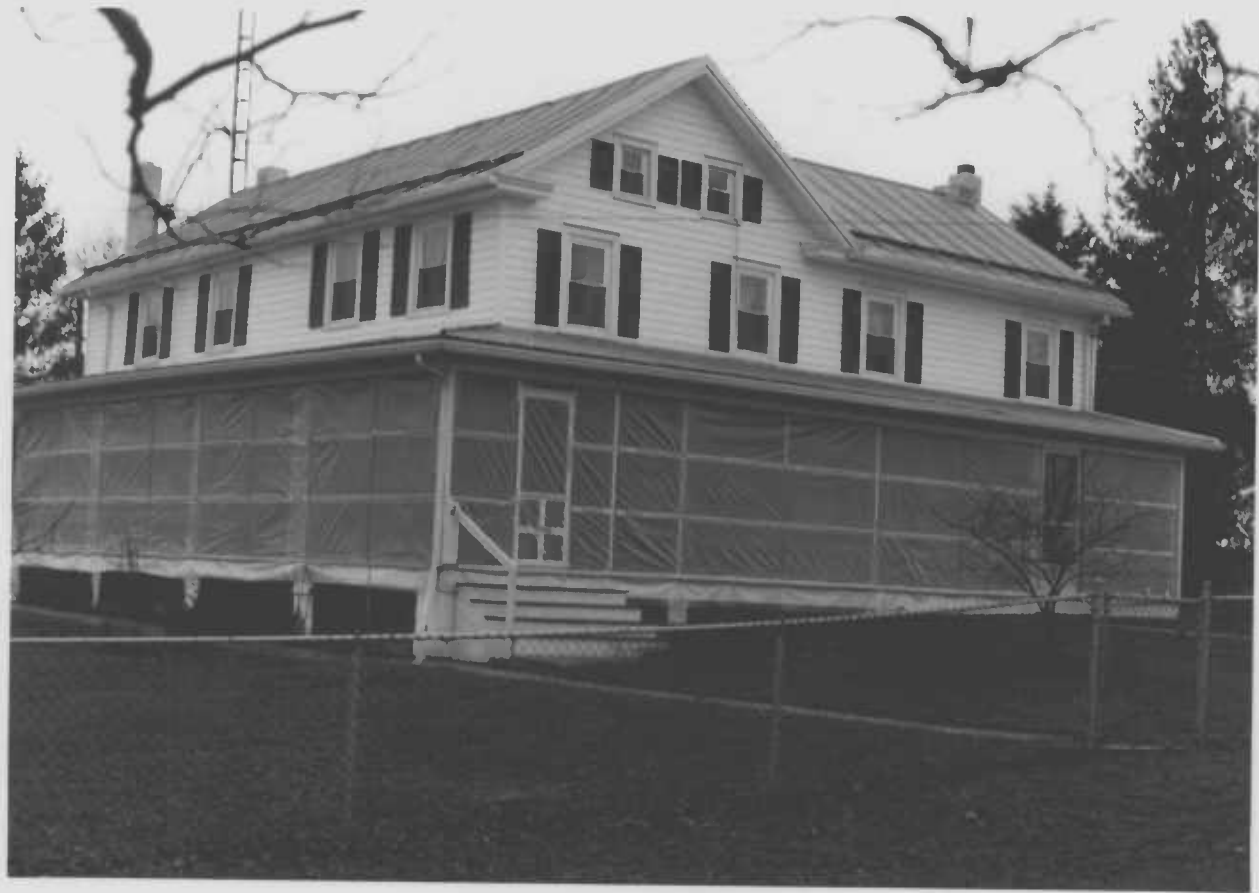
1/3

house - north - east elevations

The house is a two-story, four-bay by two-bay structure with a two-bay by three-bay ell on the west, and is covered in vinyl siding over the earlier German siding. The foundation is of rubble stone. It has a gable roof with standing seam metal covering, and box cornice with returns. The east elevation has two center doors on the first story, with a 1/1 sash in the north and south bays, and four 1/1 sash on the second story. The south central door has one light above two panels, and the north central door has one light above a lying panel, with two panels at the bottom. There is a one-story wrap-around porch on the east and north elevations, with turned posts and a standing-seam metal roof. The north elevation has two 1/1 sash on each story of the main block and two small 1/1 sash in the gable end. The wing has a door in the bay that has one light over two panels. There is a 1/1 sash on either side of the door, with two 1/1 sash on the second story. The porch extends the whole depth of the wing. The south elevation has two 1/1 sash in

each story of the main block, with two smaller 1/1 sash in the gable end. The south elevation of the wing is set back from the plane of the main block. The east bay of the wing is now an enclosed two-story porch, with a door below and 1/1 sash above. The west bay has a 1/1 sash in each story.

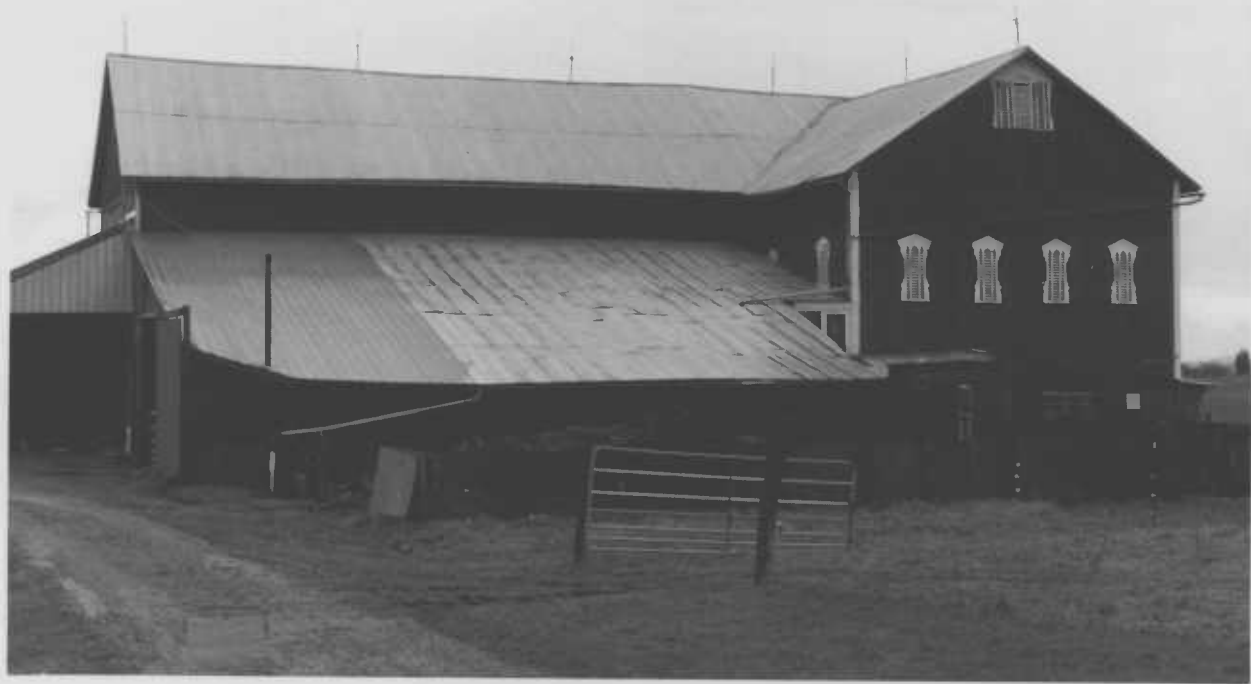
2/3

barn - east elevation

The barn was built in two stages. The first stage is a forebay, banked barn, that faces east. There is an ell attached to the north half of the east elevation, and this portion reportedly came from another barn that was taken down and moved here. The upper story of the west elevation has two pair of wagon doors, on rollers, in the center. North of these are four wood louvered vents with pedimented tops, and south of these are two like vents, but with a four-light sash in the bottom of each. There is one 6/6 sash on each side of the center ramp in the lower story. The barn has a gable roof covered with corrugated metal and five lightning rods along the north-south gable. It has a rubble stone foundation. The siding throughout is of vertical boards. The south elevation has a tripartite vent in the gable end and the remains of a shed-roofed wagon shed attached below. The east upper story of the elevation of the original section has, from south to north, three pedimented vents, a pair of doors above a second pair, all on strap hinges, another like vent, and two pairs of matching doors. The south elevation of the wing has two pedimented vents, the one to the west having a four-light sash in the bottom. These two elevations are virtually hidden from view behind a much later shed-roofed addition in the crook of the ell. The frame wall of the lower story has horizontal board siding with a beaded edge on top and bottom. From south to north there is a vertical board door on rollers, two 4/4 sash, a tongue-and-groove, vertical board dutch door, another 4/4 sash, another like dutch door, a large opening, a 4/4 sash, a like dutch door, and the remainder of the wall is open, as it is connected with the east wing. The east elevation of the wing has vertical board siding on the lower story, four pedimented vents above, and a tripartite vent in the gable end. The north elevation was not accessible.

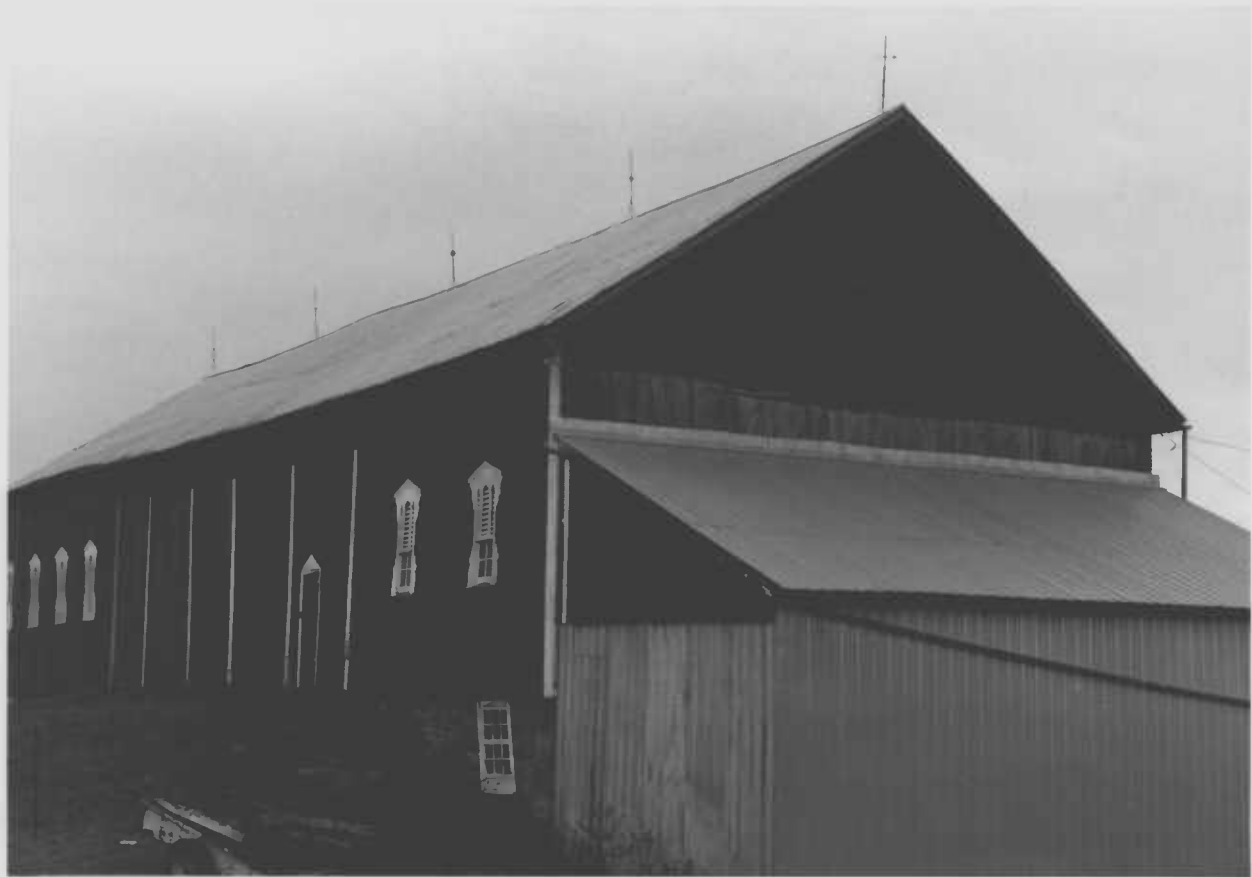
3/3

Barren - west : South elevations
